**BAGHDAD POLICE COLLEGE  
BAGHDAD, IRAQ**

**SIGIR PA-06-078.2**

**SIGIR PA-06-079.2**

SUBJECT: Report on Project Assessments of Reconstruction Work Performed Under Task Orders 06 and 29 at the Baghdad Police College, Baghdad, Iraq (Report Numbers SIGIR PA-06-078.2 and PA-06-079.2)

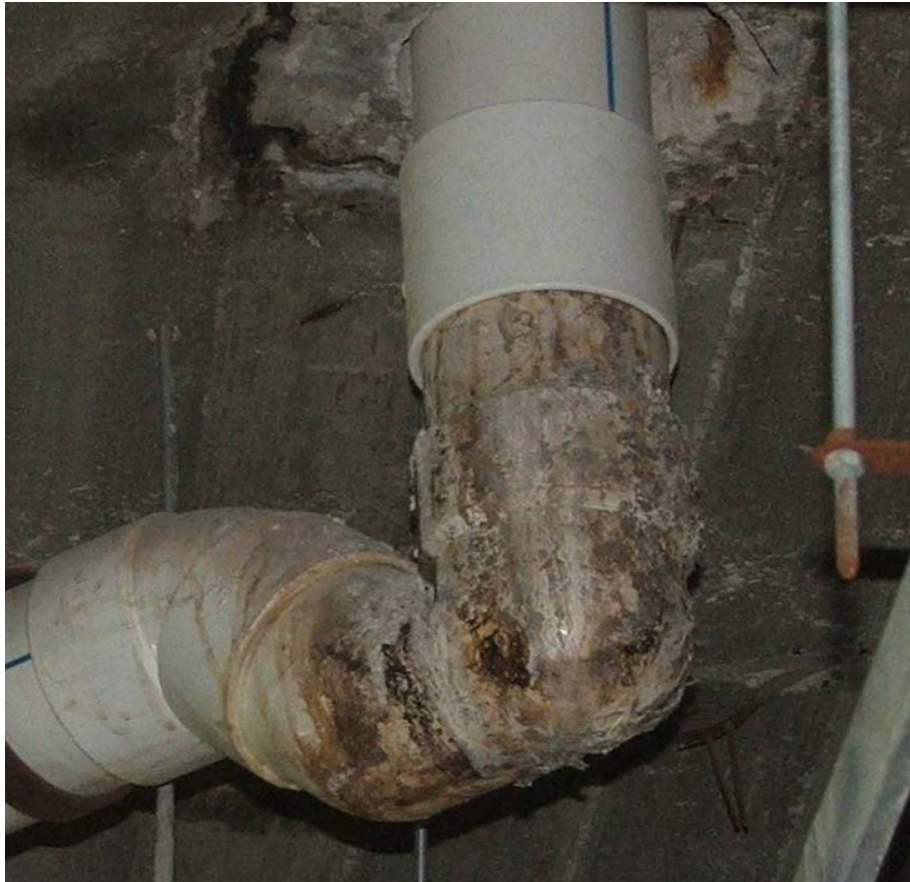
As part of its close out documentation, Parsons provided GRD with its testing results. According to Parsons' documentation for the cadet barracks buildings, the PPR (Polypropylene Random – pressure piping for hot and cold water system) pipes, sewer pipes, and rain water pipes were separately tested. The PPR test consisted of start and stop atmospheric pressures of 6.0 bar, or approximately 87 pounds per square inch (psi) (1 bar = 14.50377 psi), for 48 hours, with no reported water leakage. The sewer pipe test consisted of plugging the pipe openings and filling the pipes with water for 48 hours; there was no reported water leakage. The testing procedure for the rain water pipes was identical to the sewer pipe test, with no reported water leakage. According to the plumbing test log, cadet barracks buildings A, B, C, and D were tested and there was no water leakage. After considering the non-industry standard plumbing fittings were used in the cadet barracks bathrooms (Site Photo 62), the poor joint sealant work done by the subcontractor (Site Photo 63), and the end result of the plumbing deficiencies (Site Photo 64), we question Parsons' test results.

**Site Photo 64. End result of using non-industry standard plumbing fixtures and not sealing pipes correctly**

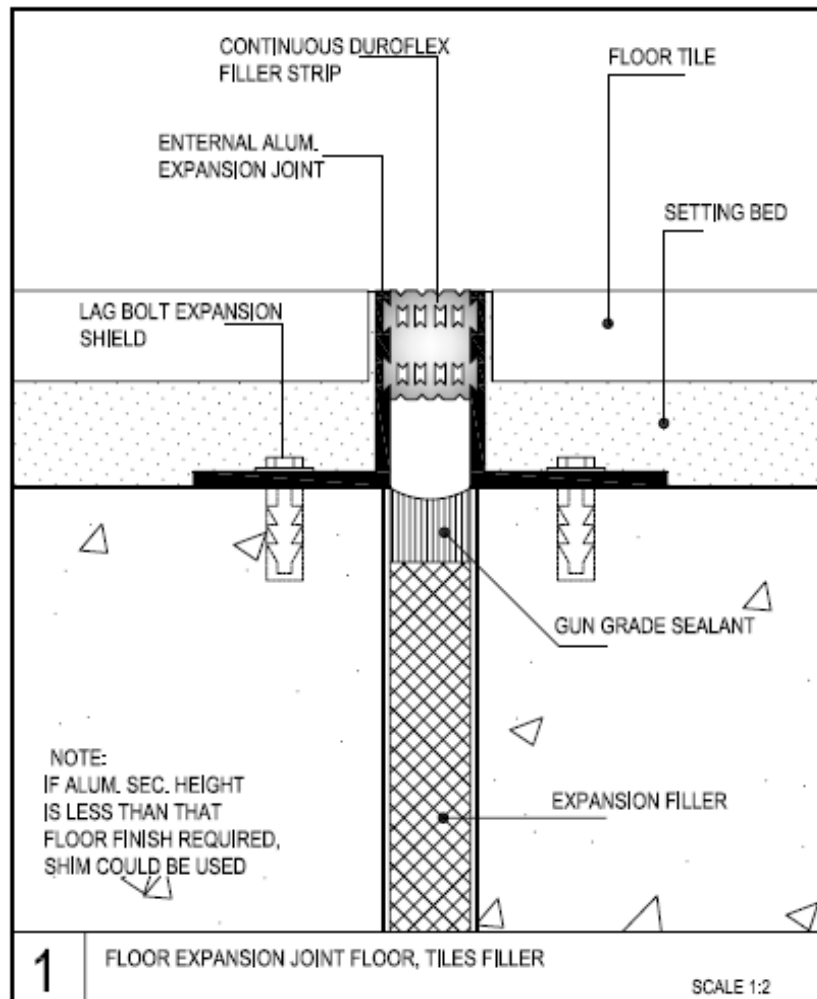
**Figure 5. Contractor's as-built drawing**

For instance, for the instructors’ barracks, we identified significant expansion cracks on the interior, exterior, and roof of the buildings (Site Photos 65-68). Parsons’ as-built drawings claim to have constructed a specific type of expansion joint system for floor, interior wall, ceiling, exterior wall, and roof (Figures 5 and 6). The as-built drawings submitted show a very specific prefabricated engineered joint system. We found little or no evidence of designed joint systems in place to protect the building from vertical and horizontal movement. When comparing the building’s construction and damage to the as-built drawings submitted by Parsons, it is apparent that the as-built drawings do not reflect the actual construction done.

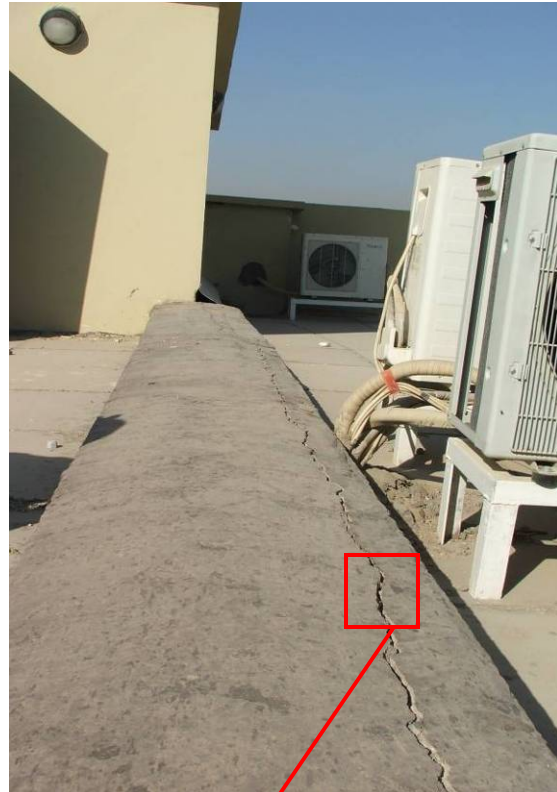
**Site Photo 67. Exterior expansion crack**

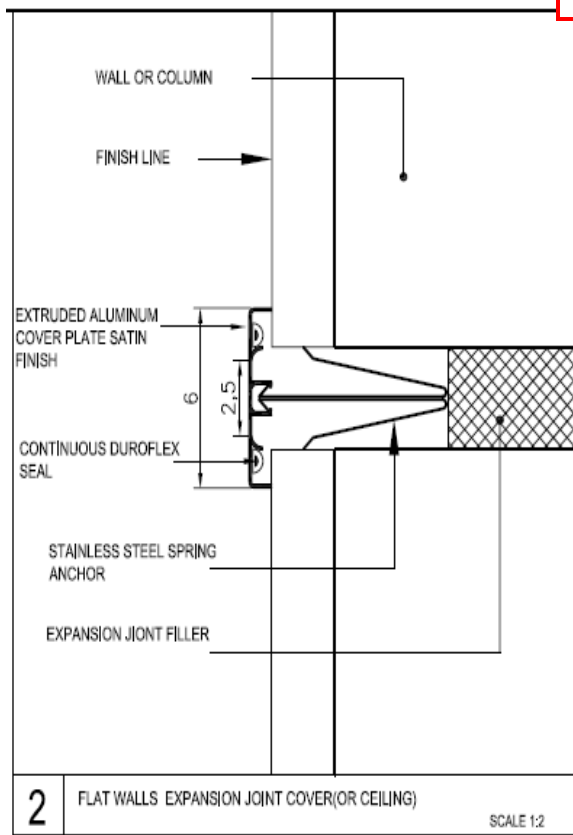
**Figure 7. Contractor's as-built drawing**

Similar to the instructors' barracks, we discovered significant expansion cracks on the interior and exterior of the language instructors' barracks (Site Photos 69 and 70). Parsons' as-built drawings required a specific type of expansion joint system for floor, interior wall, ceiling, exterior wall, and roof (Figure 7). The as-built drawings submitted show a very specific prefabricated joint system. We found little or no evidence of designed joint systems in place to protect the building from vertical and horizontal movement. When comparing the building's construction and damage to the as-built drawings submitted by Parsons, it is apparent that the as-built drawings do not reflect the actual construction done.

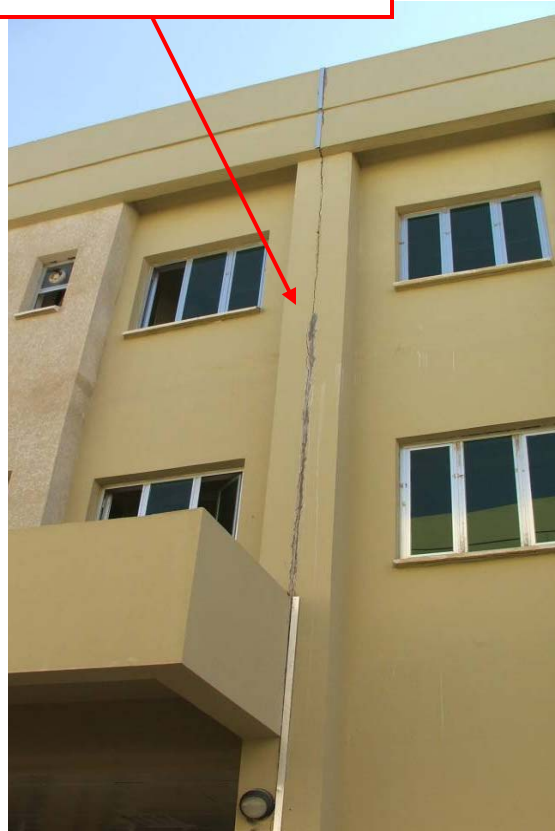
Major expansion crack on front side of building (absence of engineered joint)

**Site Photo 69. Exterior expansion crack**

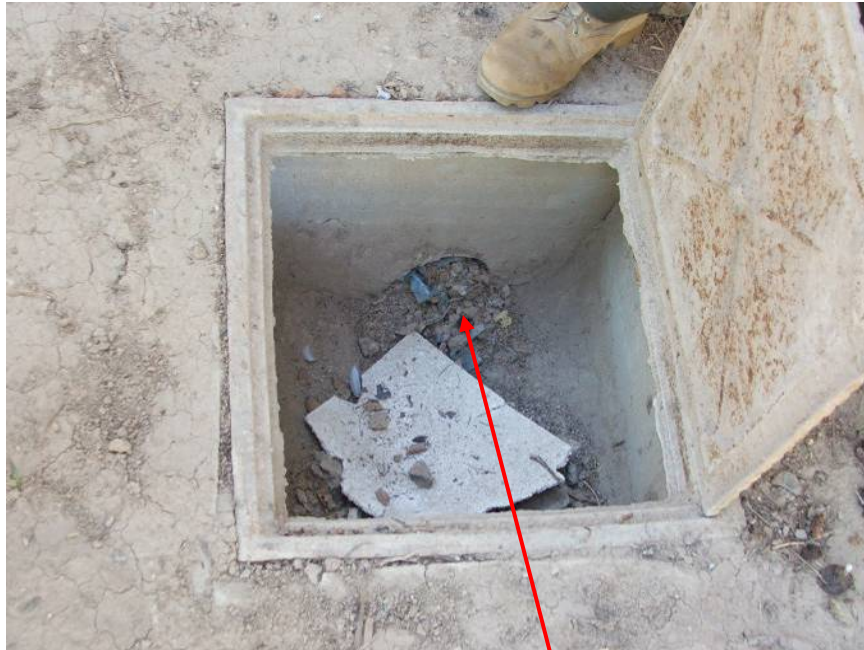
Finally, for the ablution unit, the as-built drawings submitted by the contractor indicate the facility is connected to the main water and sewage networks (Figure 8); however, during our initial site visit, we verified the facility was not connected to either the main water or sewage networks (Site Photo 71). The connection to the main water and sewage networks was not completed until late November 2006 and was completed by another contractor.

**Site Photo 71. 10 November 2006 site visit, documenting ablation unit not connected to the sewer network.**

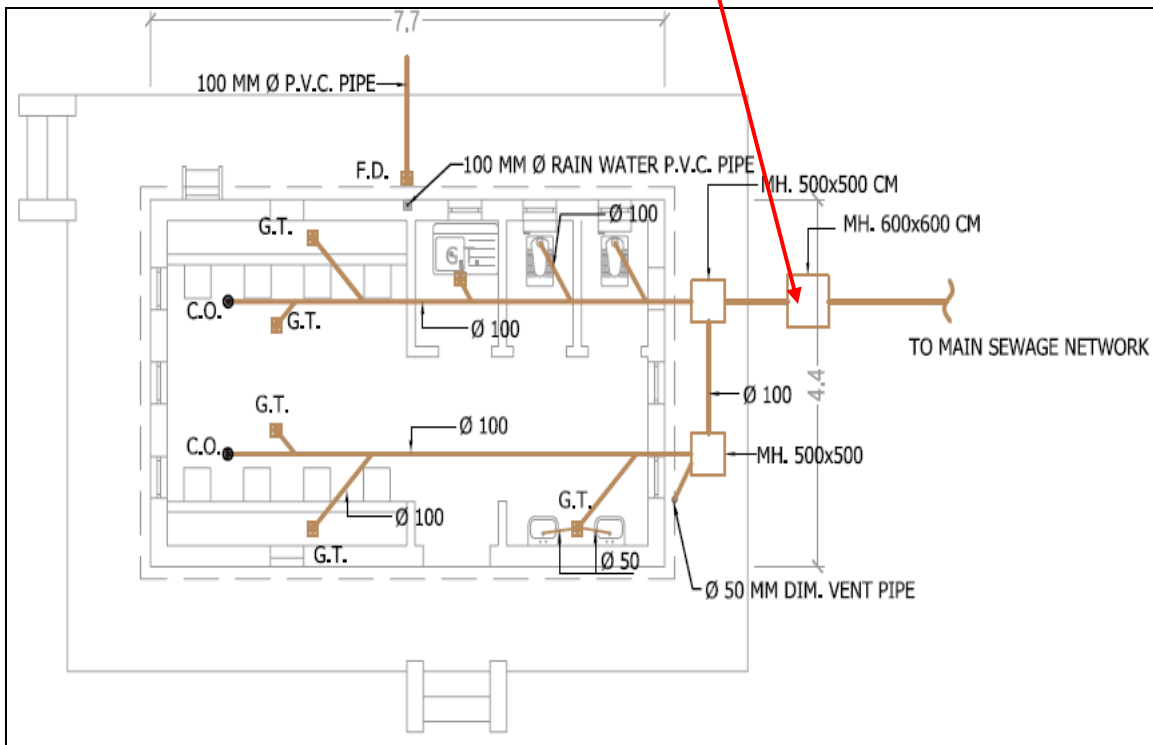
**Figure 8. Contractor's as-built drawing for ablation unit, which indicates connection to main water and sewage networks.**

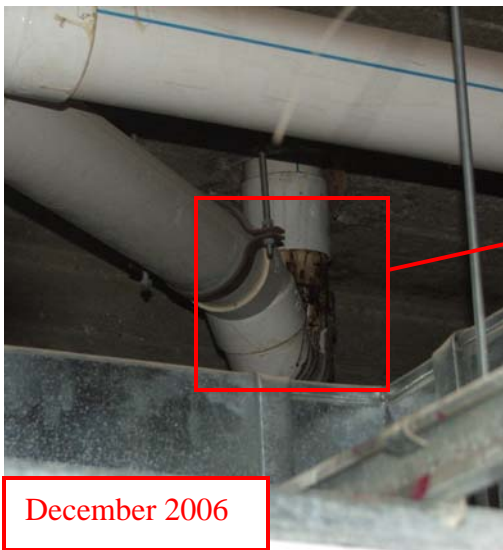
**Site Photo 80. Leaking waste water from poorly sealed pipes**

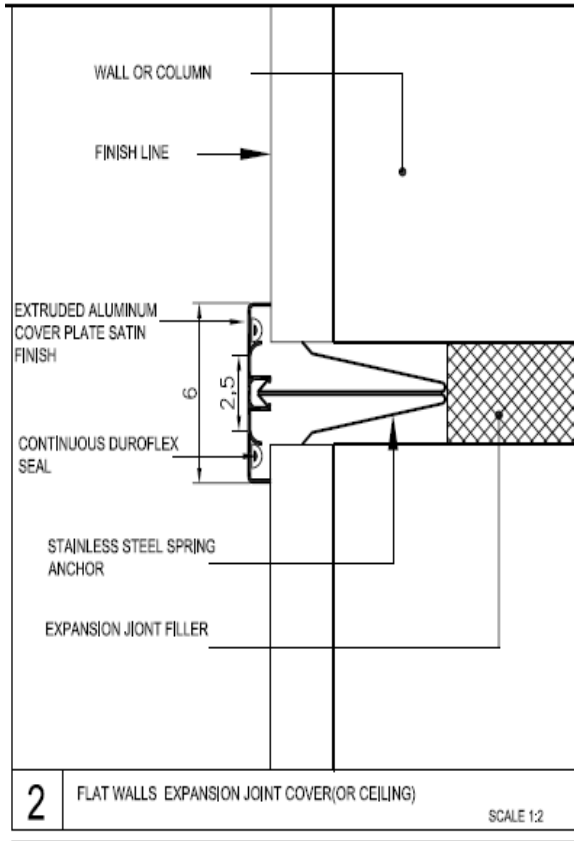
**Figure 9. Contractor's as-built drawing**

The contractor's as-built drawings, in our opinion and in GRD's own assessment, are not complete and accurate. For example, the as-built drawings for the instructors' barracks buildings show a very specific prefabricated joint system (Figure 9). We found little or no evidence of designed joints in place to protect the building from vertical and horizontal movement. Not only did the instructors' barracks suffer from significant interior and exterior expansion cracks (Site Photos 82 and 83) and runs the risk of reducing the buildings' life expectancy, equally troubling is the fact the GRD does not know if the contractor was paid for installing the prefabricated joint system claimed in the as-built drawings. The government already paid Parsons for inaccurate as-built drawings (since the as-built drawings reference prefabricated expansion joints which are not present on the buildings) and quite possibly paid Parsons for the installation of the prefabricated joint system.

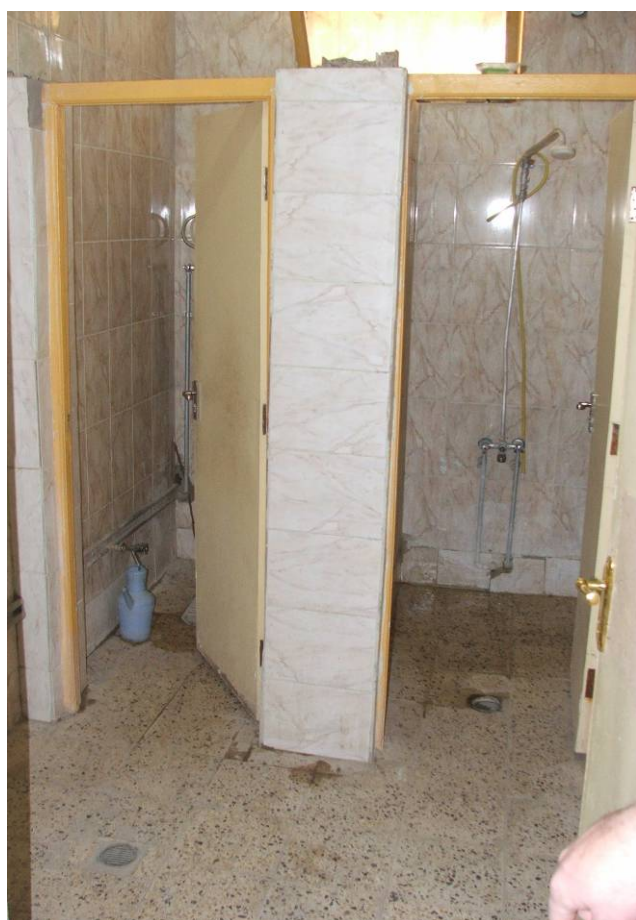
**Site Photo 87. Renovated interior of BPC security office**

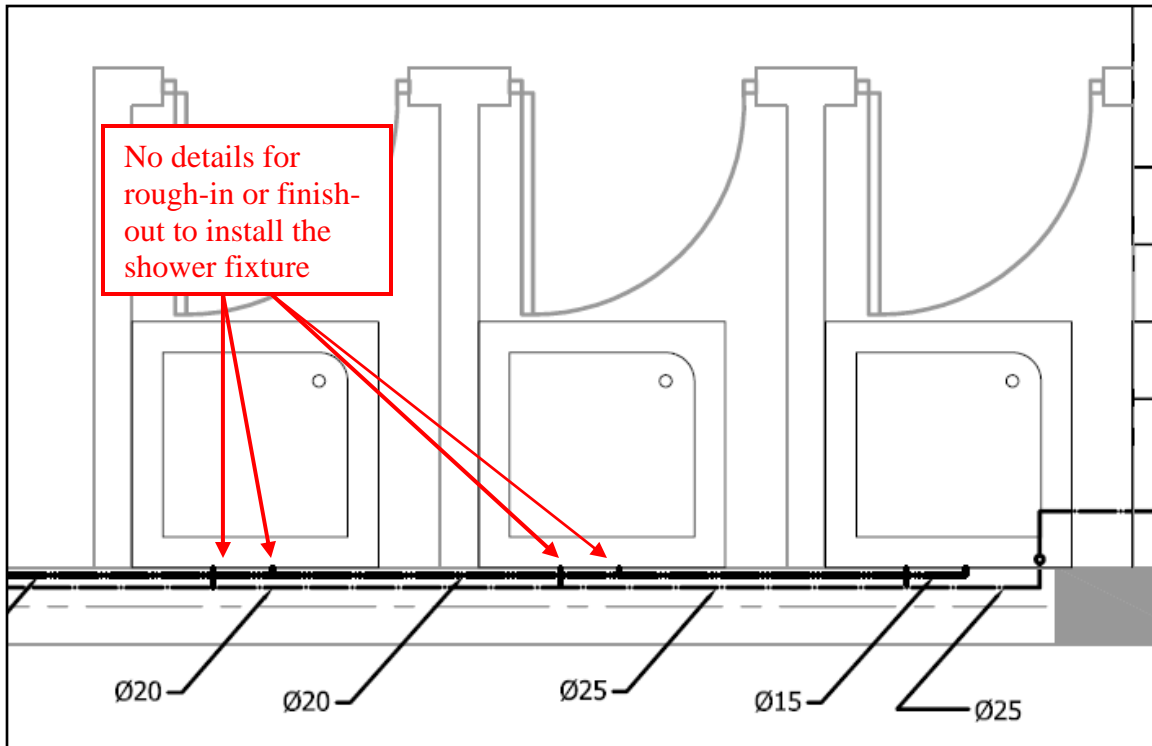
Detailed design drawings for the rough-in and finish-out of the plumbing fixtures were not provided by the contractor. Instead the drawings were generic and did not specify the distance that the hot and cold water lines should extend beyond the wall (i.e. rough-in) for the plumber to connect to the shower faucet and head (Figure 10). In addition, the drawings do not provide an enlargement of one shower as an example to provide specific installation details, such as the type of plumbing fixtures to use (i.e. finish-out). Without detailed design drawings, the subcontractor does not have adequate guidance to properly install the water lines and plumbing fixtures.

Figure 10. Contractor design for installation of hot and cold water lines for cadet barracks showers

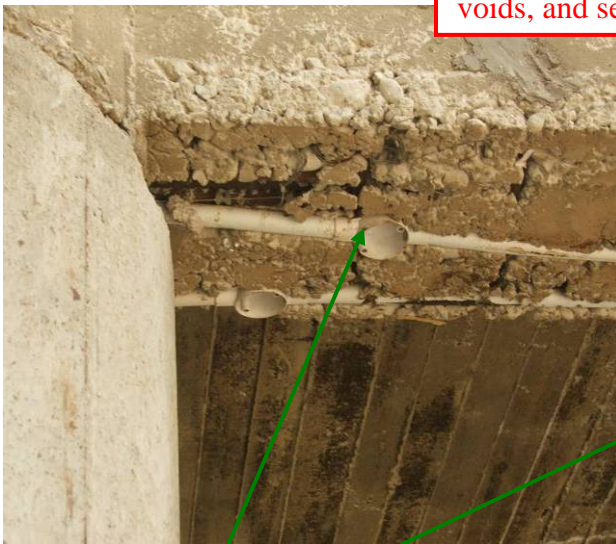
Areas of honeycombing, voids, and segregation

**Site Photo 92. Concrete segregation and electrical conduit exposure**

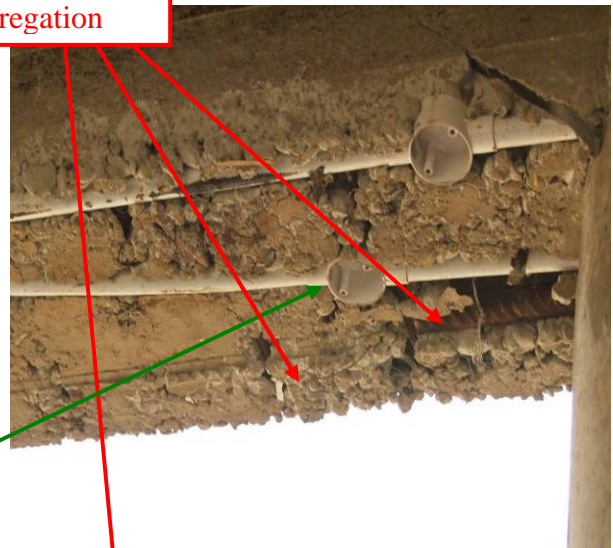
**Site Photo 93. Concrete segregation and electrical conduit exposure**

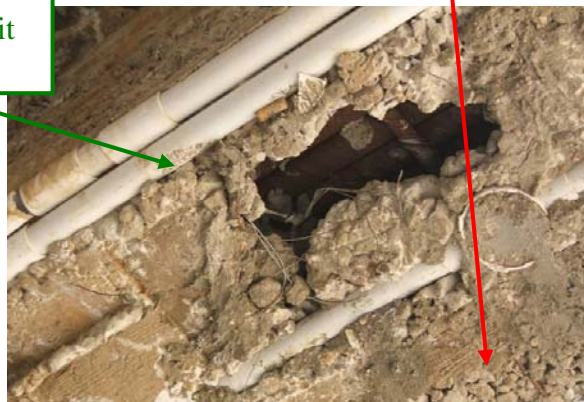
Electrical conduit exposure

**Site Photo 94. Concrete voids and electrical conduit exposure**

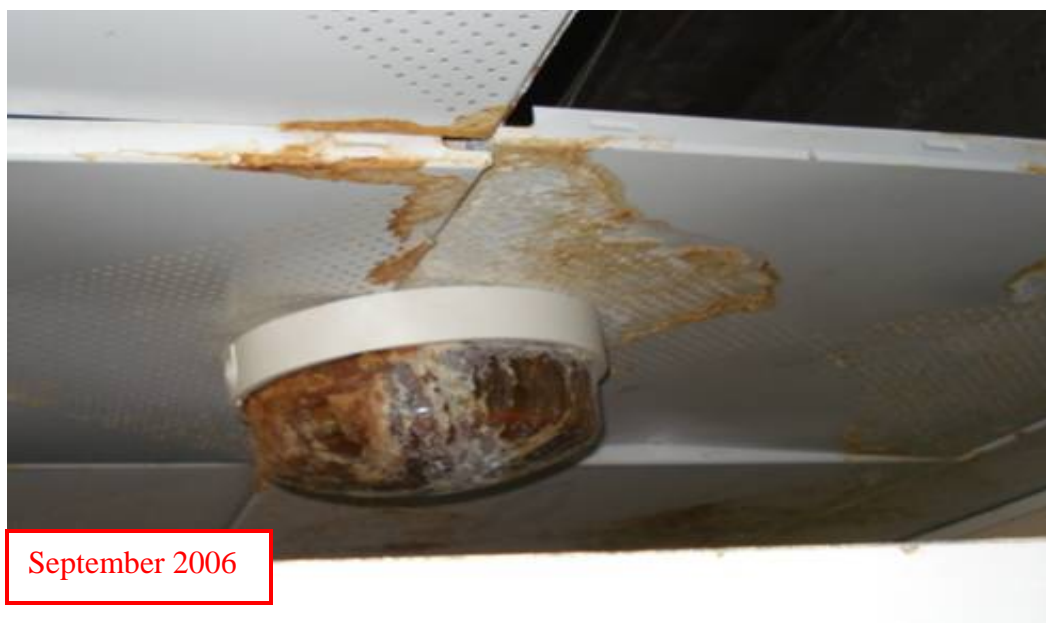
Upon close examination of multiple light fixtures in November 2006, the substance we saw (Site Photo 97) appeared to be quite similar in appearance to the urine and fecal matter we witnessed in our initial site visit (Site Photo 98). In addition, the GRD comments do not address the substance on the outside of the light fixtures. Again, this substance appears to be very similar to the substance we witnessed on the outside of the lighting fixtures on our first site visit.

**Site Photo 98. Urine-filled light fixture in cadet barracks bathroom from original construction**

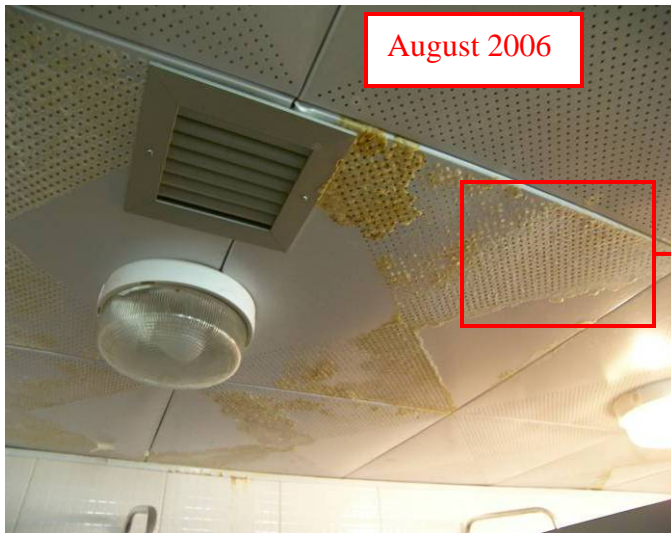
**Site Photo 100. Urine stain on second floor ceiling**

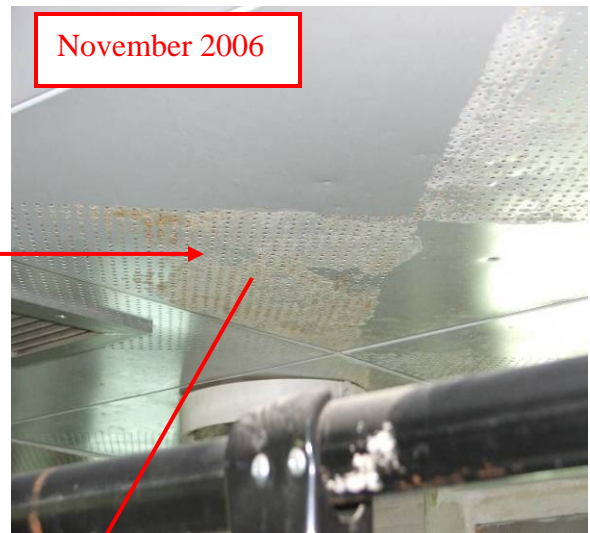
Finally, we do not find any validity to GRD's claim that the "crystallized deposits shown in photo 181 are salt deposits from fresh water leaking through the concrete floor above." First of all, when comparing a current photo (Site Photo 101) of the ceiling panel damage to a photo from our original site visit, which the GRD concurred was crystallized urine deposits (Site Photo 100), the damage appears to be identical. It must be noted that the damage in the original site visit photo is more substantial because the plumbing issues had been on going for several months, while the damage from November 2006 occurred in the "reworked/repared" plumbing that had only been used for a few weeks.

**Site Photo 101. Urine stain on second floor ceiling  
(photo referred to in GRD comments)**

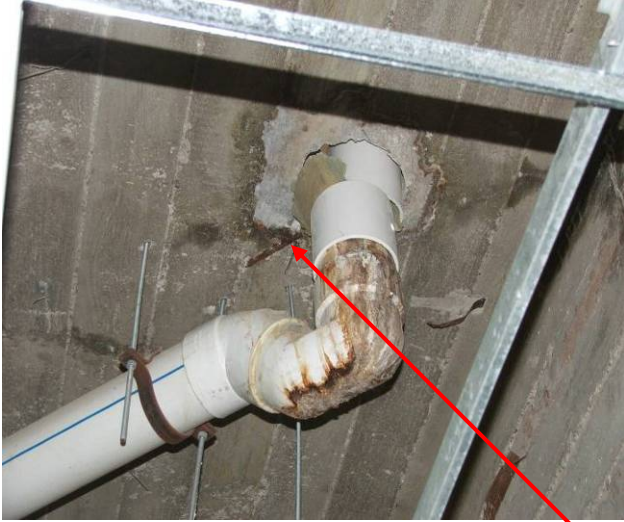
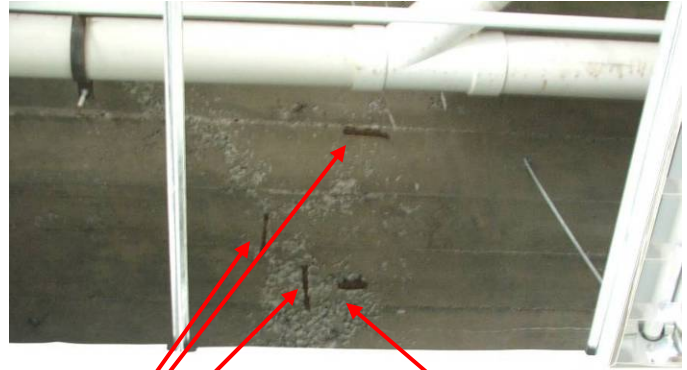
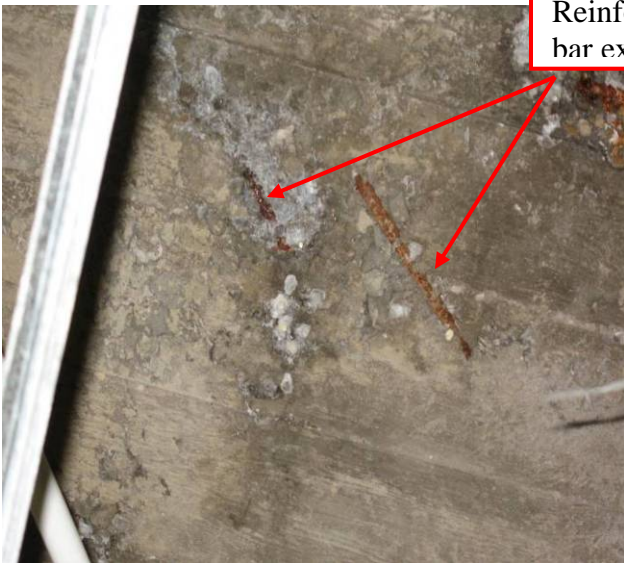
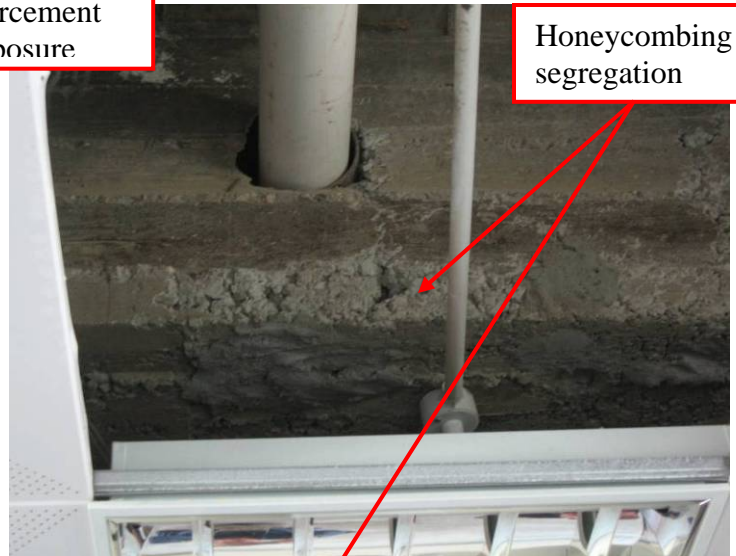
In a previous inspection report, we identified significant plumbing issues within the cadet and instructors' buildings<sup>11</sup>. The suspended ceilings of the cadet barracks buildings were removed to show us water damage. We identified segregation, honeycombing, and voids in the structural concrete members as well as exposed reinforcement bars (Site Photos 104-108).

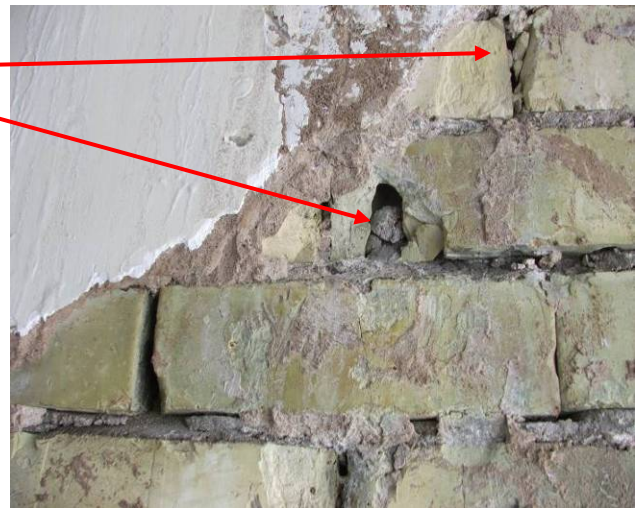
In the ground floor common area, we witnessed the effects of leaking water from the top two floors (Site Photo 109). The water damage to the walls was so extensive that the plaster had to be removed. When the plaster was removed, we identified evidence of poor quality brick and masonry work of the non-load bearing walls, such as broken pieces of brick and spaces between the bricks filled with small chips of material (Site Photo 110).

**Site Photo 110. Close-up view of brickwork from Site Photo 109**

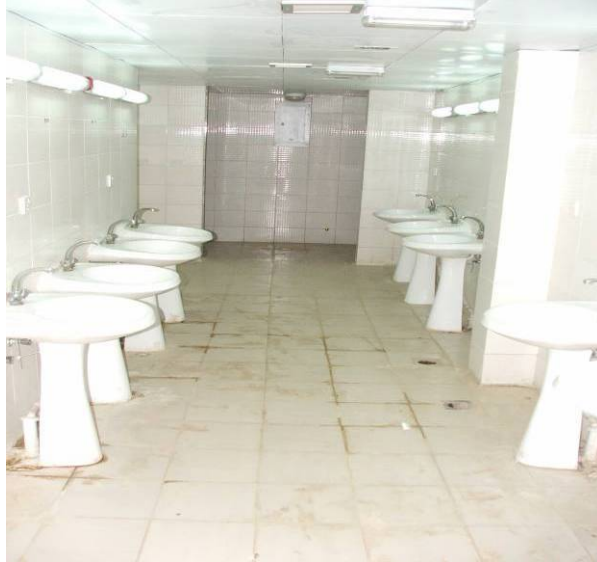
Each multiple occupancy cadet bedroom was approximately 5.5 meters (m) wide by 6.5m long and consisted of six bunk beds housing 12 cadets (Site Photo 111). Inside each room were a ceiling fan, two windows, two ceiling lights, and a split air conditioning unit. We identified poor construction techniques employed for the door frames (Site Photo 112). The first and second floor communal bathrooms consisted of 11 urinals (Site Photo 113), one dressing/changing room, two western and eight eastern-style toilets (Site Photo 114), 10 showers, and nine sinks (Site Photo 115). During our site visit, we noticed problems with the bathroom fixtures, such as low quality sinks and sink fixtures, shower fixtures and assemblies, and hoses (Site Photo 116), which resulted in broken fixtures and leaks (Site Photos 117 and 118).

**Site Photo 115. Sinks in cadet barracks bathroom**

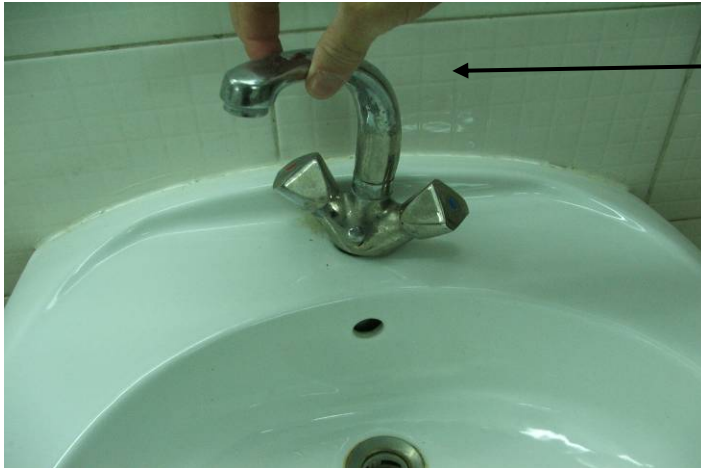
Faucet not securely attached  
and moved by hand

**Site Photo 116. Example of low quality sink fixtures**

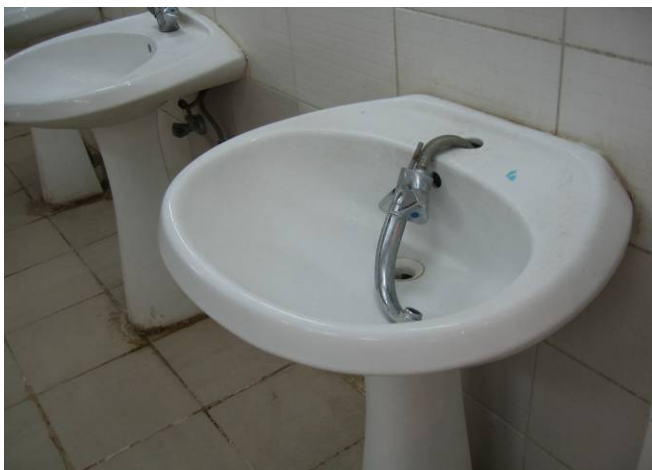
**Site Photo 117. Broken sink fixture**

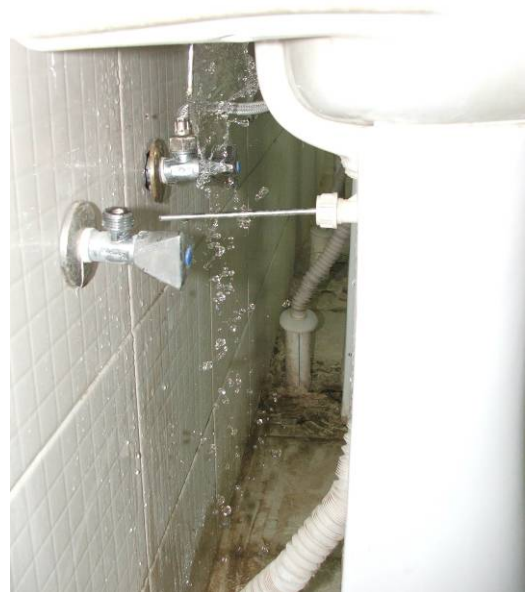
**Site Photo 118. Leaking water**

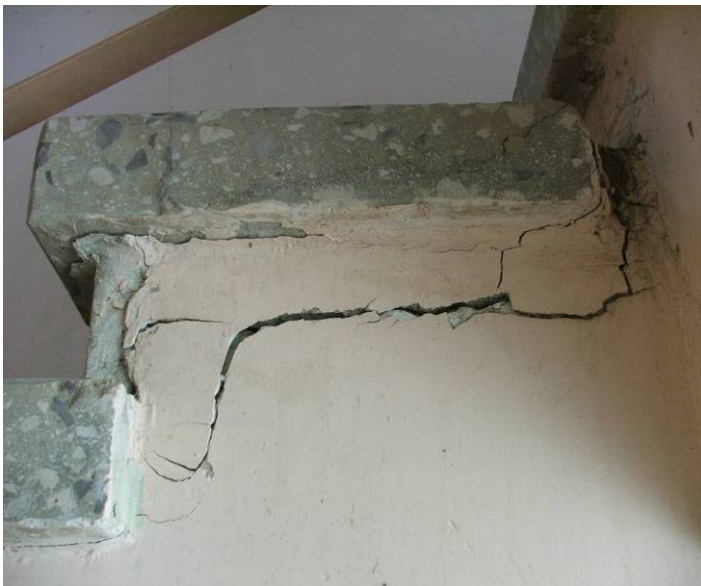
Finally, we identified structural deficiencies with the staircase; specifically the de-lamination of one step (Site Photo 120) and a large crack of another staircase (Site Photo 121). Underneath the staircase, we identified what appear to be stress cracks (Site Photos 122 and 123).

**Site Photo 120. De-lamination of staircase step**

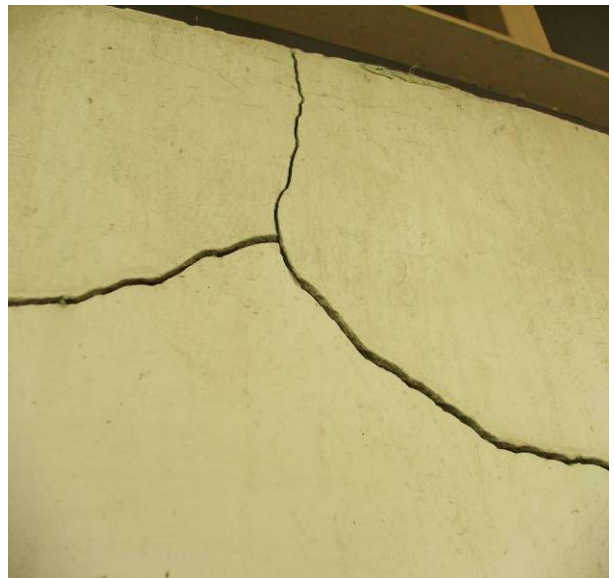
**Site Photo 121. Staircase crack**

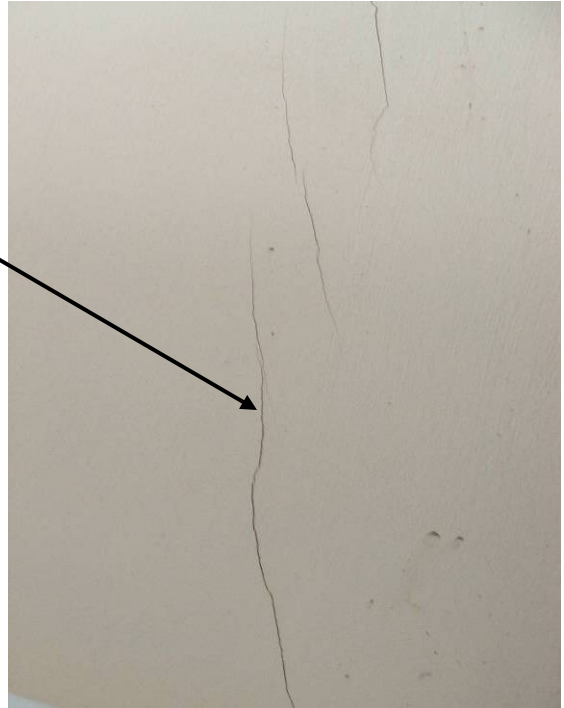
**Site Photo 123. Enlarged view of Site Photo 122**

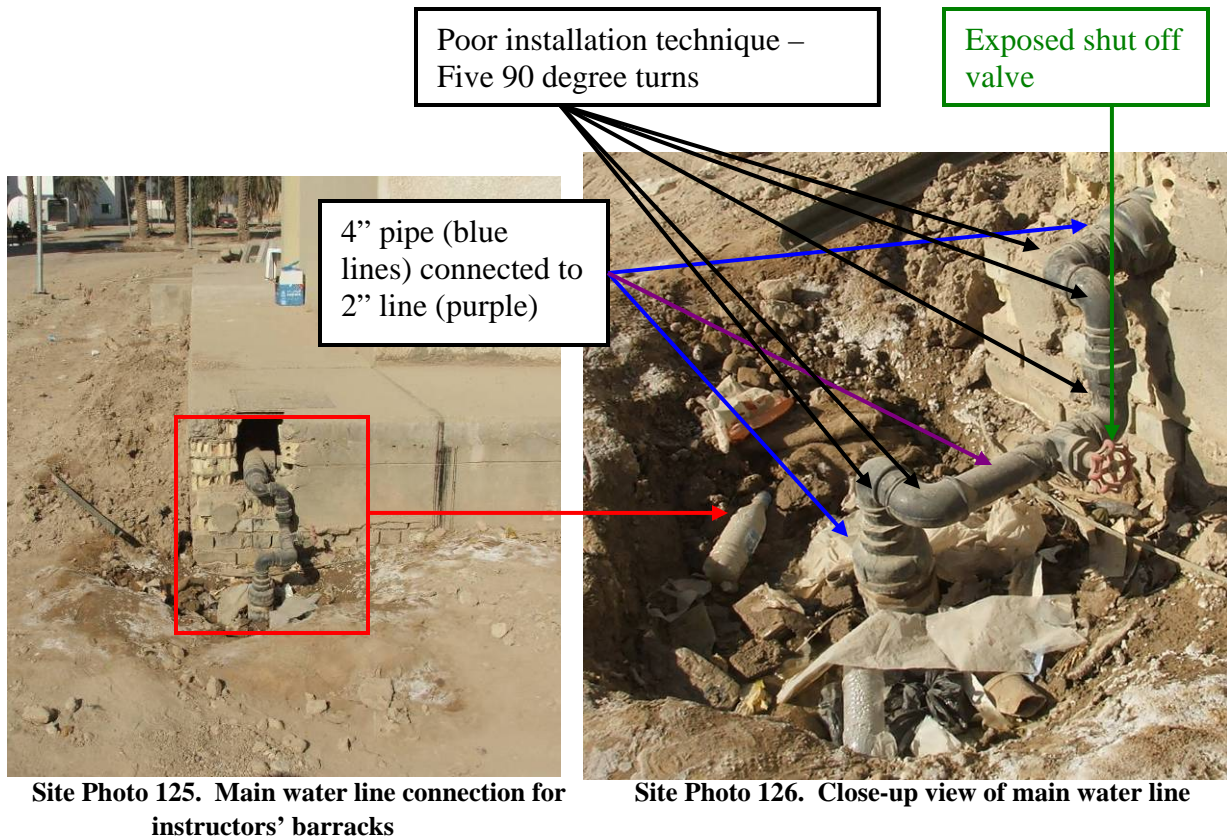
Prior to entering the building, we identified the main water line connection (Site Photo 125). This water line connection is poorly installed. It has five separate 90 degree turns from the pipe exiting the ground to the line in the foundation (Site Photo 126); the pipes and shutoff valve are exposed to the elements (i.e., water and sun, which will ultimately lead to rust), and the pipes are not covered to reduce the chance of damage from vehicle traffic (since the pipe line is close to the street). According to GRD's independent assessment, the "...standard method of construction is to secure the shut off valve inside a cast iron box with cast iron cover." Finally, the main water line connection is peculiar since multiple sized pipes are utilized. Specifically, there is a reduction from the 4" main pipe to a 2" pipe and then expanding to a 4" pipe (Site Photo 126).

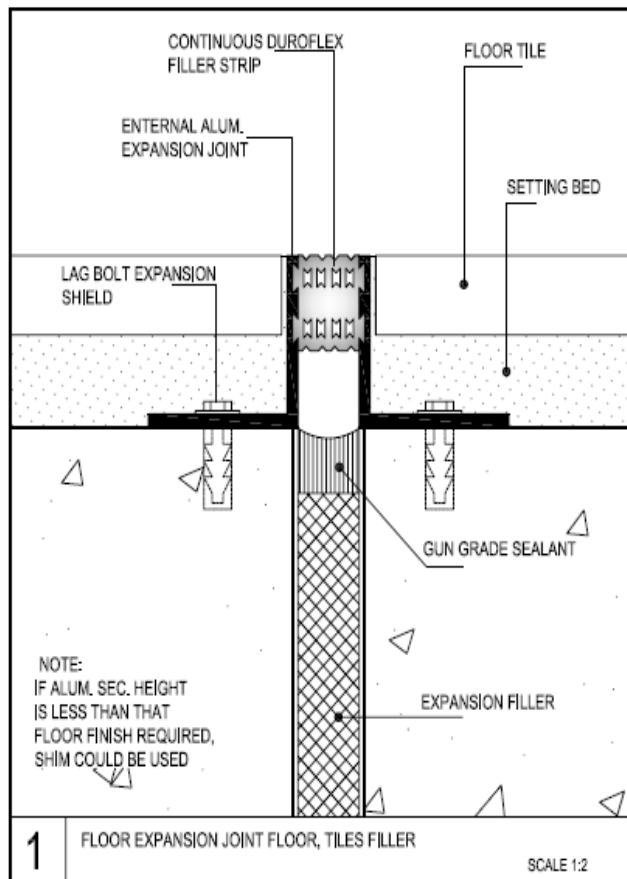
**Figure 11. As-built drawing for expansion joint**

More importantly, we discovered significant expansion cracks on the interior and exterior of the buildings. The contractor submitted as-built drawings claiming to have installed a specific type of expansion joint system for the floor, interior wall, ceiling, exterior wall, and roof. The as-built drawings submitted show a very specific prefabricated joint system. The materials and methods to install each type of joint require a high level of skill, experience, and understanding; however, from the expansion cracks we verified, it appears the contractor did not have the skill level, experience, and understanding to adequately install the expansion joints.

We found little or no evidence of designed joints in place to protect the building from vertical and horizontal movement. Properly designed and correctly installed joint systems are capable of protecting buildings and structures from damage caused by thermal expansion and contraction as well as anticipated foundation movements. The damage we identified is a direct result of not properly installing the expansion joints according to the as-built drawings (Figures 11 and 12 and Site Photos 132-135). The absence of properly installed expansion joints could potentially result in further damage to the buildings' interior and exterior, as well as, significantly reduce the buildings' life expectancy.

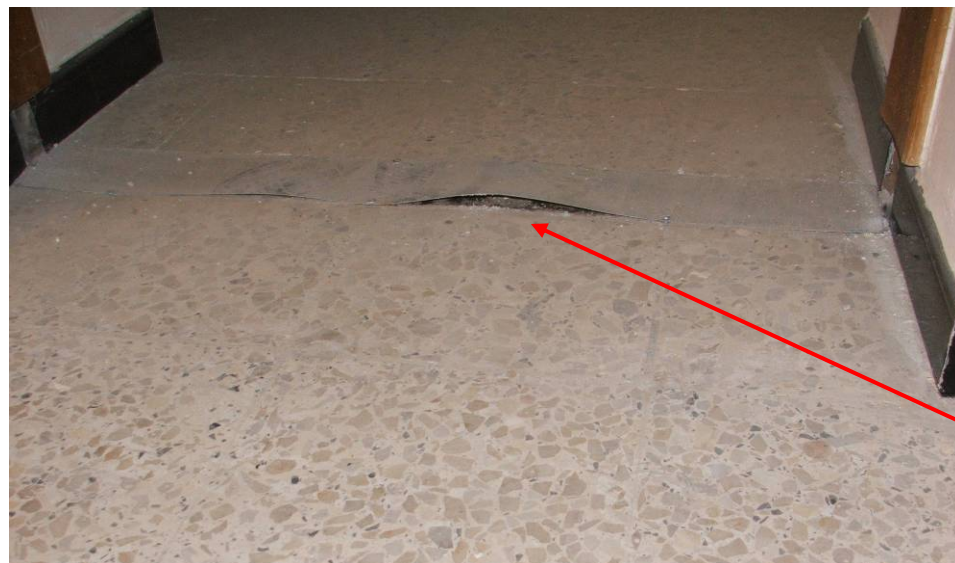
**Site Photo 133. Interior expansion crack in the instructors' barracks**

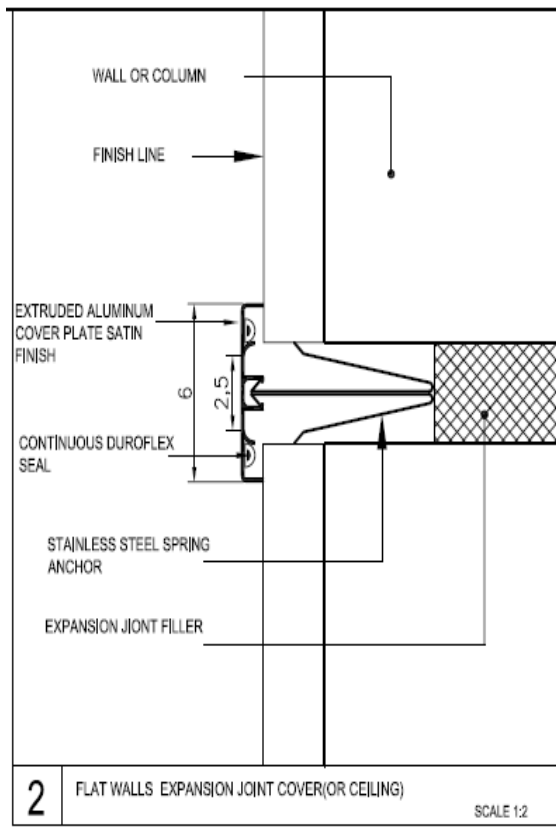
**Figure 13. As-built drawing for expansion joint**

Similar to the instructors' buildings, we discovered significant expansion cracks on the interior and exterior of the buildings. The contractor's as-built drawings required a specific type of expansion joint system for the floor, interior wall, ceiling, exterior wall, and roof. The as-built drawings submitted show a very specific prefabricated joint system. The materials and methods to install each type of joint require a high level of skill, experience, and understanding; from the expansion cracks we verified, it appears the contractor did not have the skill level, experience, and understanding to adequately install the expansion joints.

We found little or no evidence of designed joints in place to protect the building from vertical and horizontal movement. Properly designed and correctly installed joint systems are capable of protecting buildings and structures from damage caused by thermal expansion and contraction as well as anticipated foundation movements. The damage we identified is a direct result of not installing the expansion joints according to the design drawings (Figure 13 and Site Photos 138 and 139). The lack of properly installed expansion joints could potentially result in further damage to the buildings' interior and exterior, as well as, significantly reduce the buildings' life expectancy.

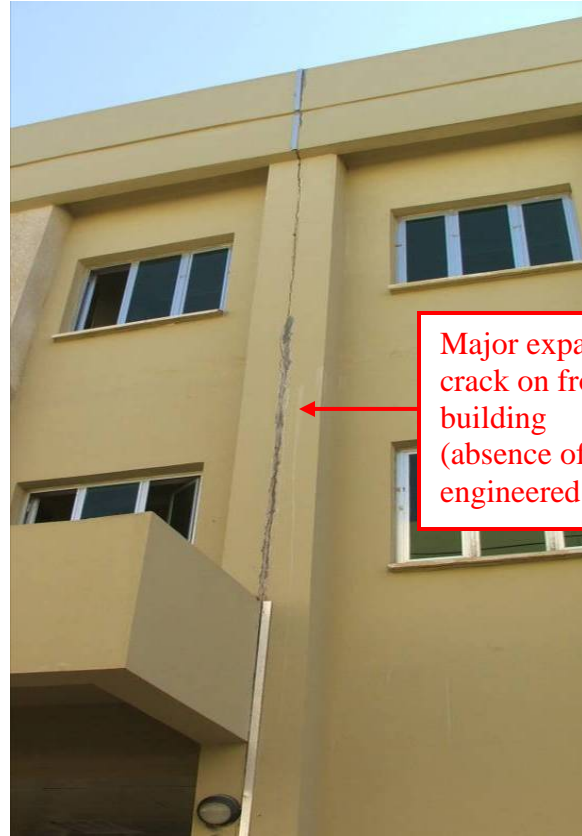
**Site Photo 138. Exterior expansion crack**

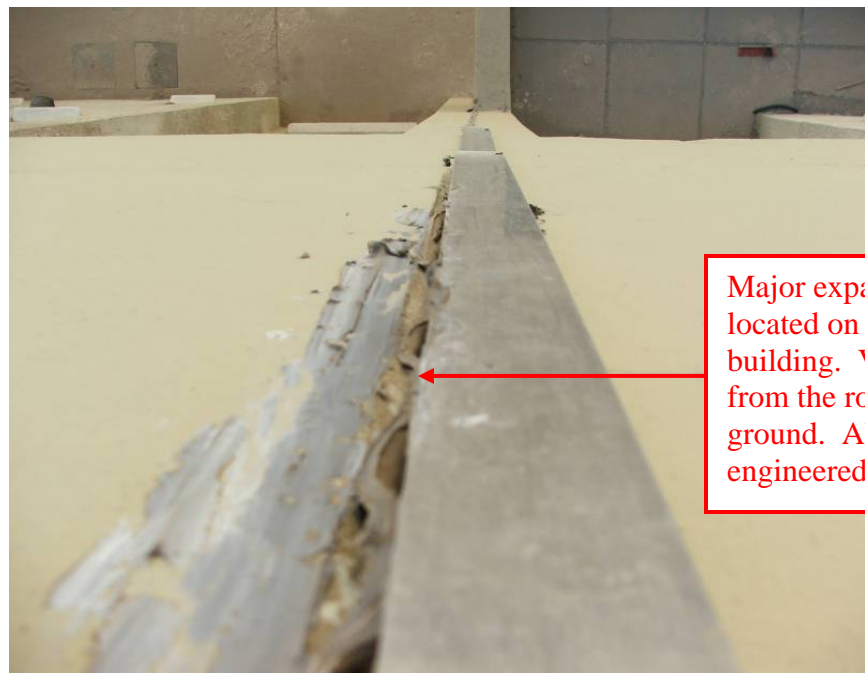
**Site Photo 139. Significant exterior crack in the language instructors' barracks**

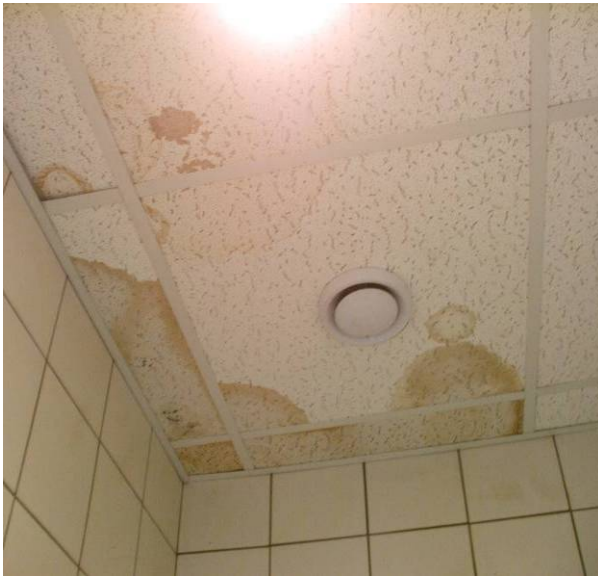
In the ground floor male bathroom area, we witnessed the effects of leaking water from the top floor (Site Photo 141). The classroom plumbing issues apparently were similar to the problems experienced in the cadet and instructors' barracks – poor installation practices coupled with defective pipes and fittings.

**Site Photo 141. Example of water damage**

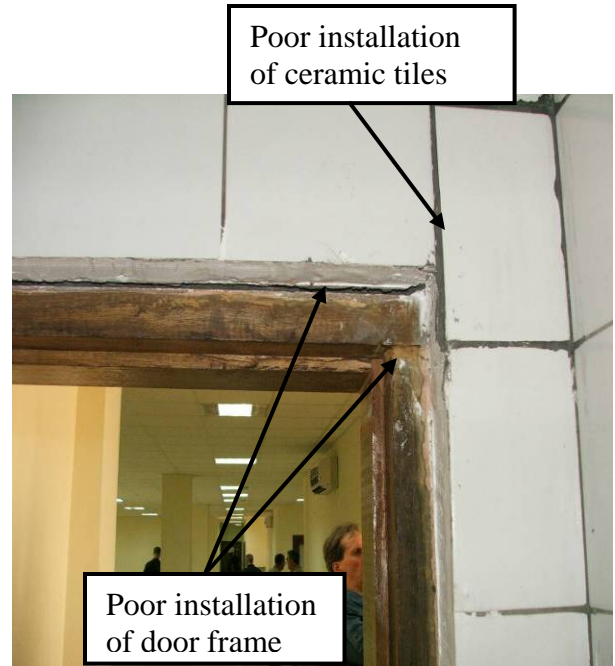
In addition, we identified evidence of poor and/or improper installation of door frames and ceramic tiles, specifically in the bathroom areas (Site Photo 142).

**Site Photo 142. Example of poor installation**

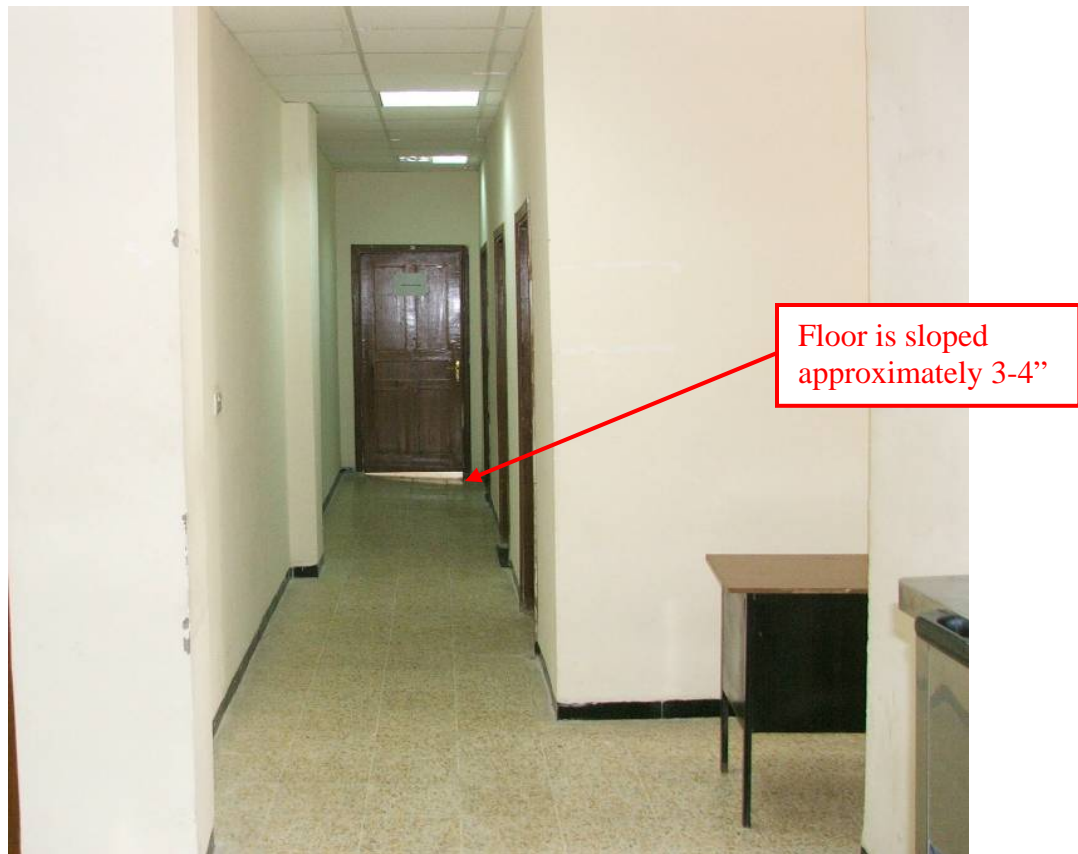
Further, the ground floor of Classroom E was not flat (Site Photo 143). The floor sloped downward to the right when approaching the female bathroom.

**Site Photo 143. Poor construction of the first floor in Classroom E**

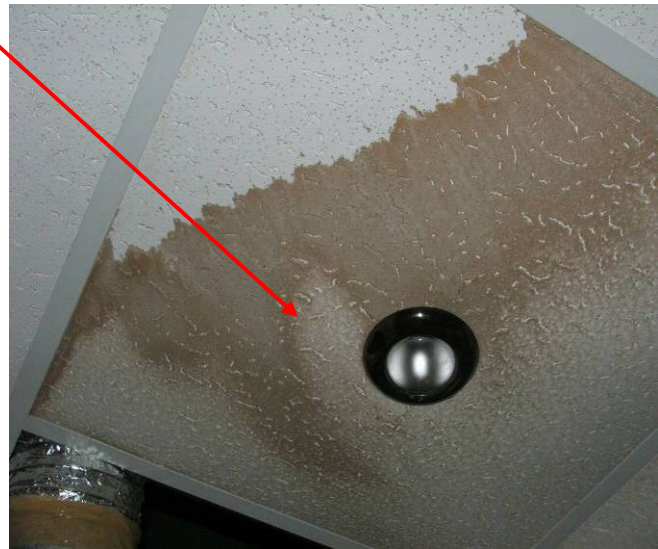
**Site Photo 151. Close-up view of water damage**
